**MARYLAND HISTORICAL TRUST
DETERMINATION OF ELIGIBILITY FORM**

Property Name: SHA Bridge No. 0100800, MD 36 over Jennings Run Inventory Number: AL-V-A-314

Project: Reevaluation of Highway Bridges Statewide MD Agency: FHWA/MD SHA

MIHP No. AL-V-A-314
SHA Bridge No. 0100800
MD 36 over Jennings Run
Allegany County, Maryland

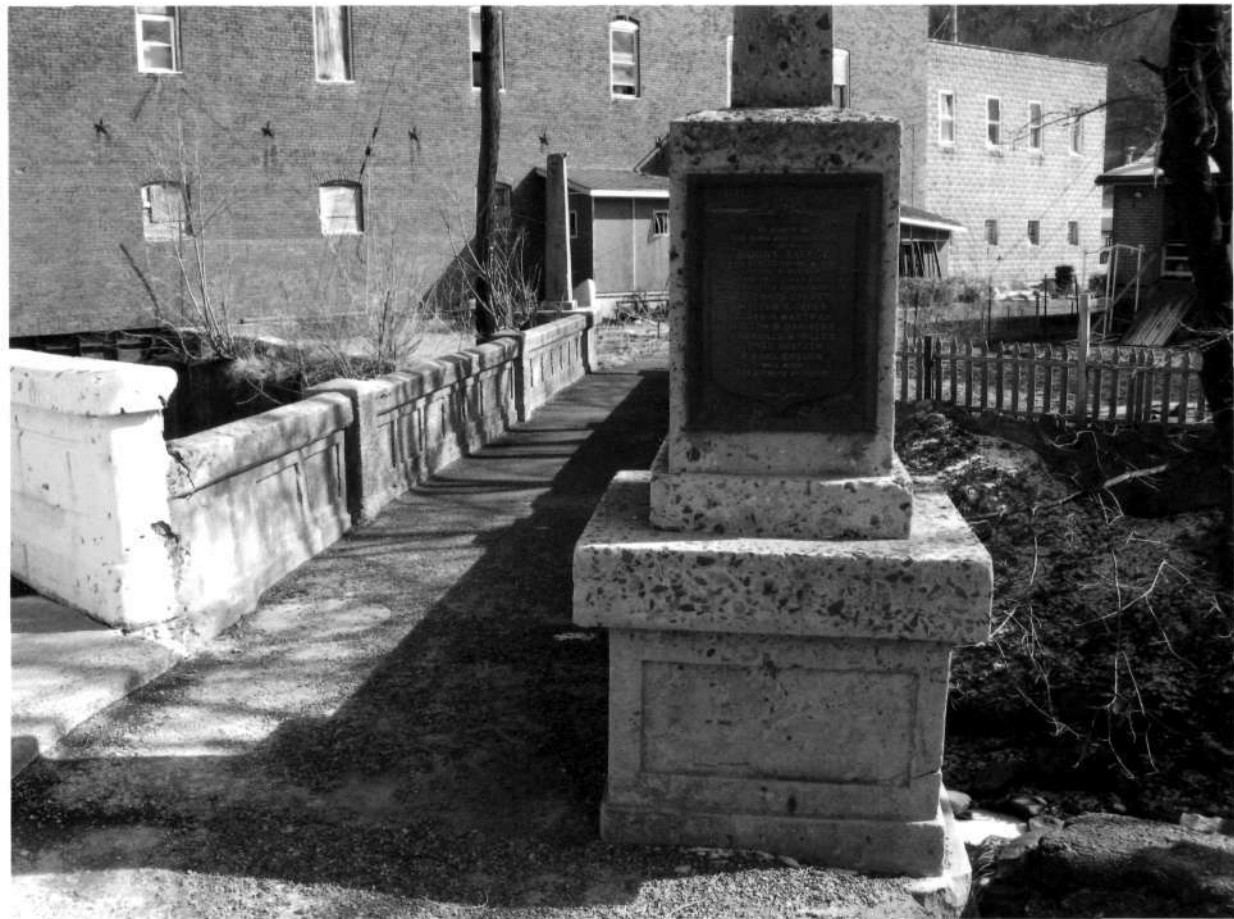
2/5

Original bridge plans of the bridge (SHA Bridge Plans 1929) show lampposts at all four corners. The fixtures were built by the Lamp Standards Union Metal Manufacturing Company in Canton, Ohio. These fixtures have been removed from the bridge. The southeast corner of the bridge is attached to the northeast corner of a walking bridge that is dedicated to fallen war veterans. The walking bridge is shown on the original SHA Bridge Plans.

Monument and footbridge southeast corner, facing
north east

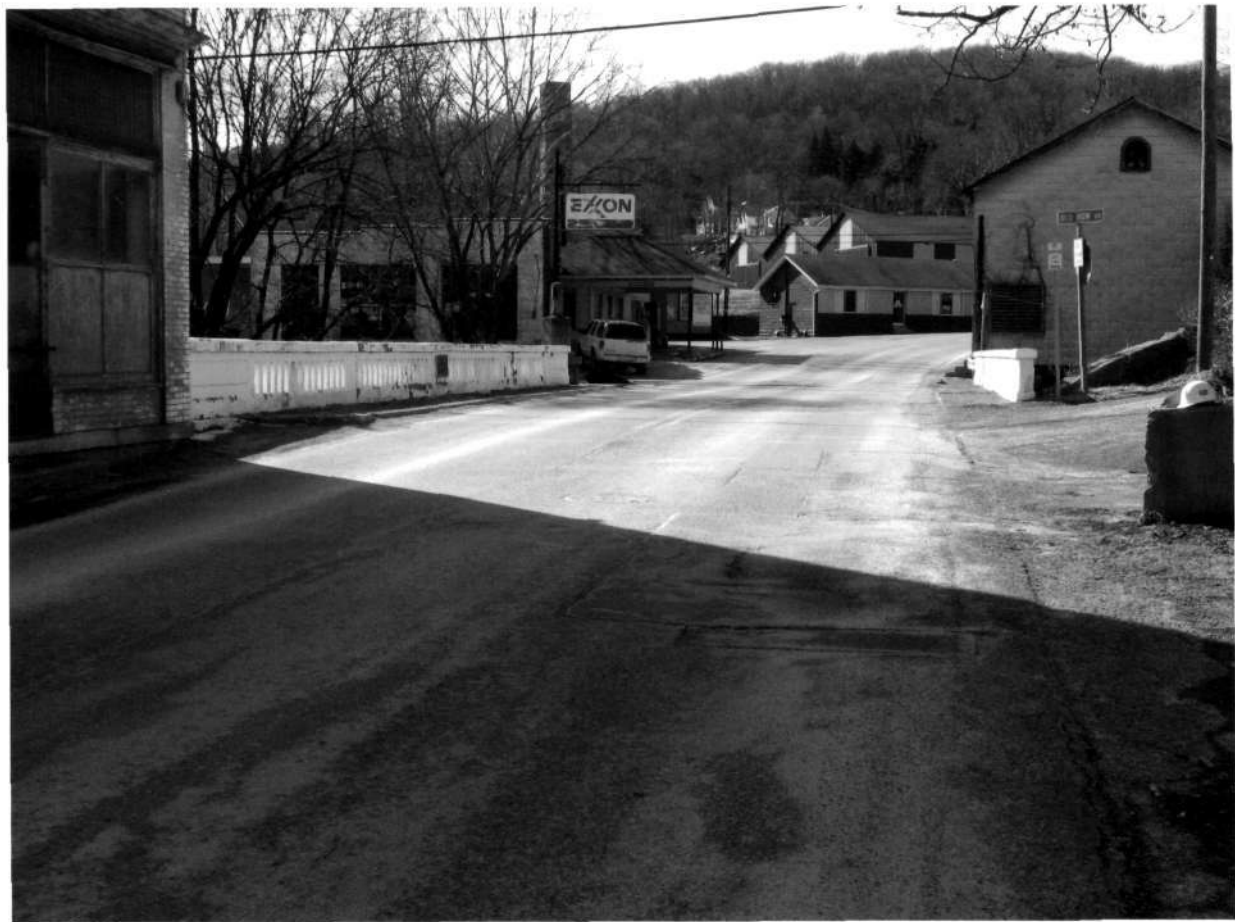
3/5

North approach, facing south

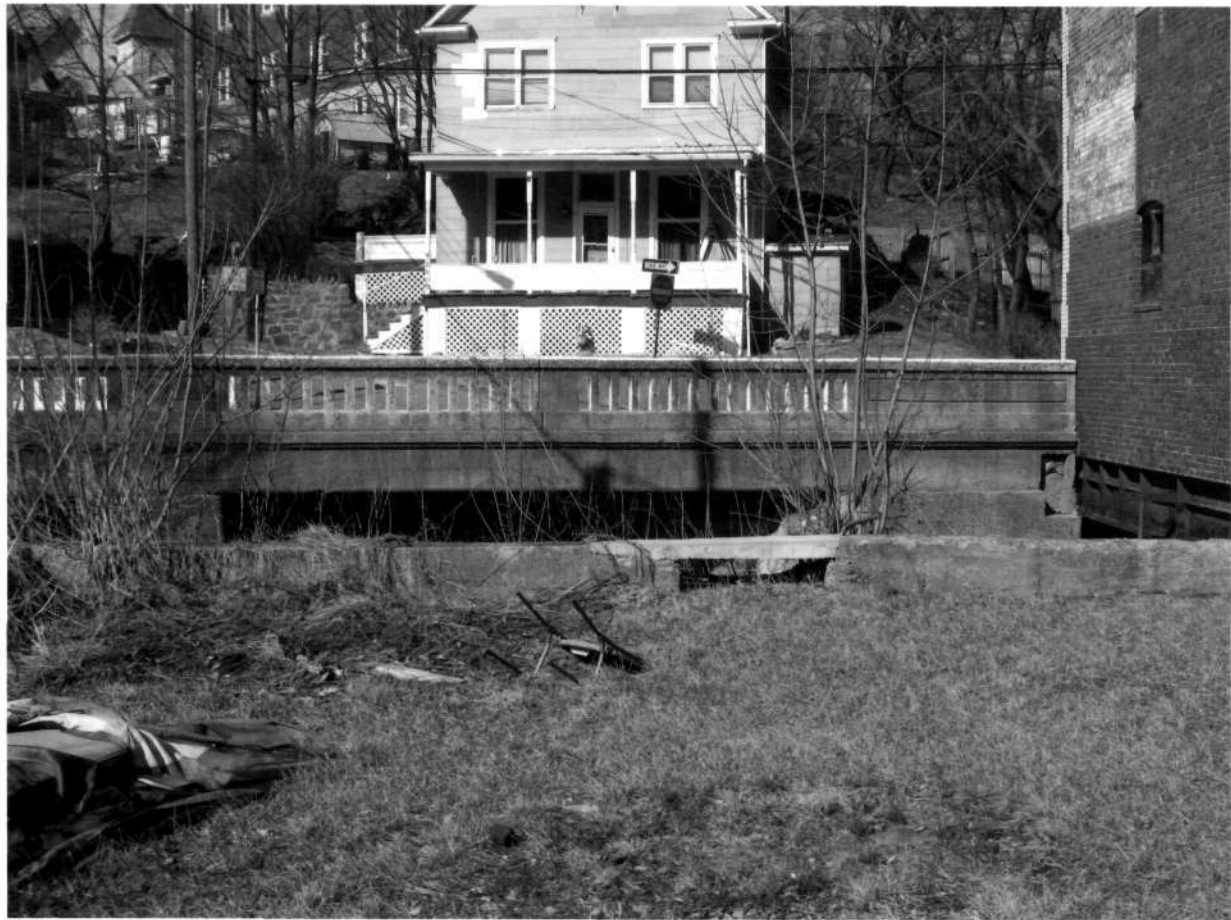
4/5

East elevation, facing west

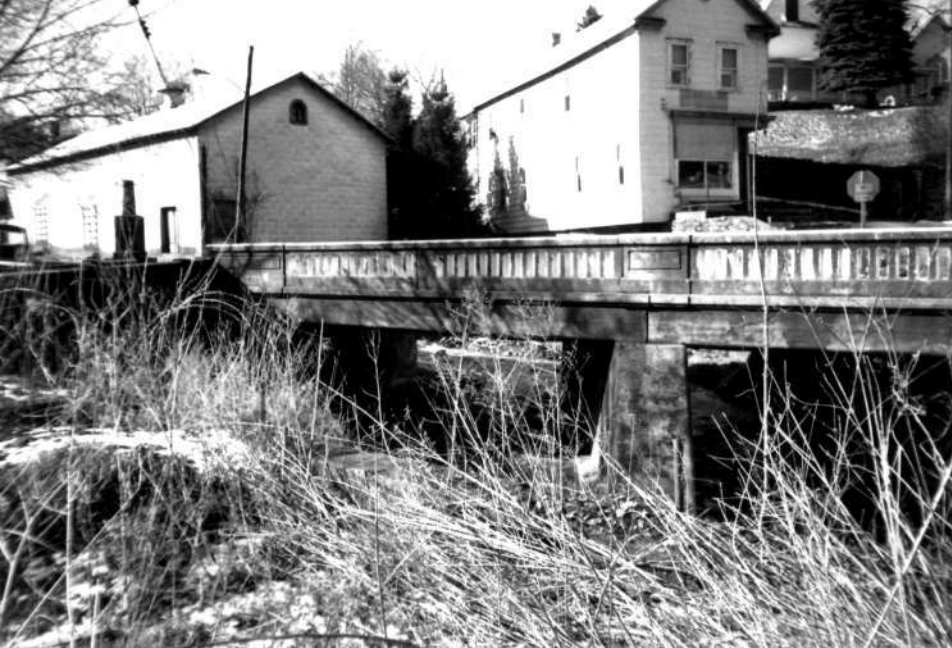
1. AL - V - A - 314
2. MD 36 over Jennings Run
3. Allegany Co, MD
4. Ryan McKay
5. 3/97
6. MD SHPO
7. Downstream elevation - south span
8. 1 of 6

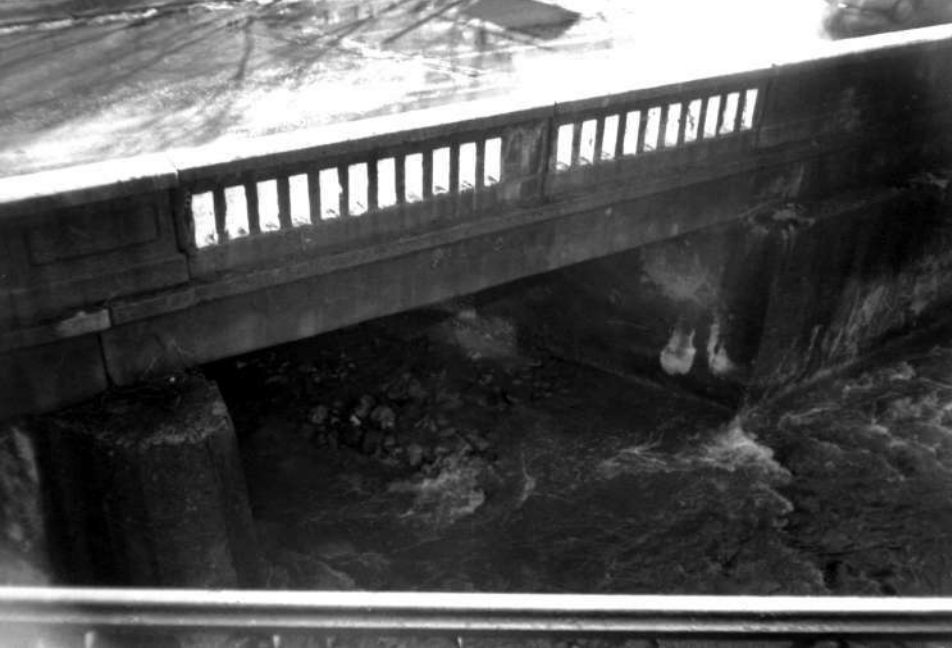
1. AL-V-A-314
2. MD 36 over Jennings Run
3. Allegany Co, MD
4. Ryan McKay
5. 3/97
6. MD SHPO
7. Upstream elevation - South Span
8. 2 of 6

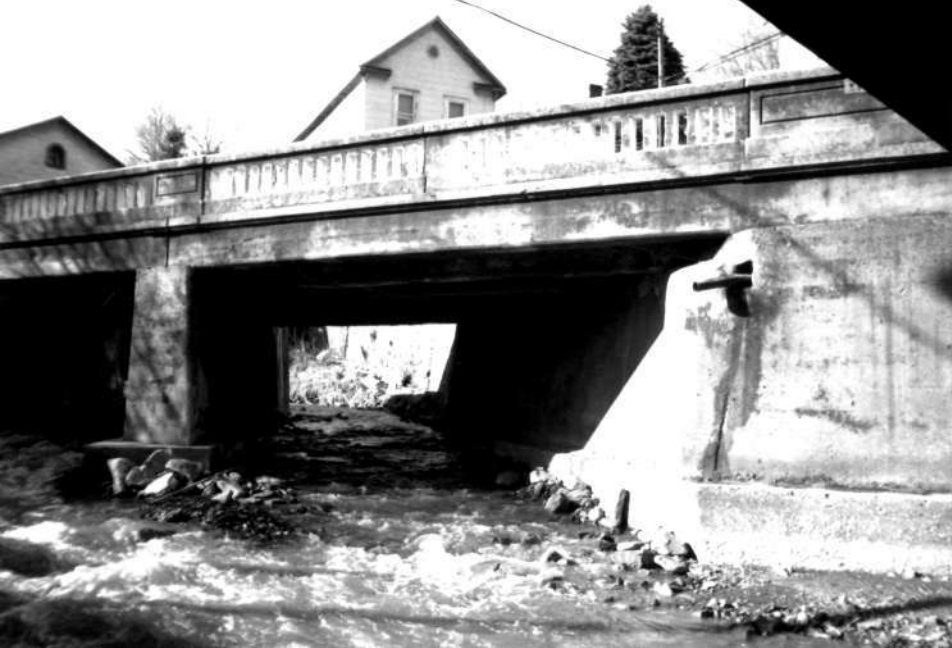
8. 4 of 6

According to the 1997 inspection report, this structure is in fair condition with some scour at the abutments and piers. During the field survey conducted by P.A.C. Spero & Company, it was noted that the concrete substructure and superstructure have areas of cracking, scaling, and spalling. The concrete beams have areas of scaling, spalling, and rusting. The asphalt wearing surface has depressions in the traffic lanes. Also, the concrete parapets are in good condition, with some areas of spalling. The parapets have been painted, and there are areas of chipped and flaking paint.

1. ALV-A-314
2. MD 36 over Jennings Run
3. Allegany Co, MD
4. Ryan McKay
5. 3/97
6. MD SHPO
7. Detail of beam
8. 3 of 6

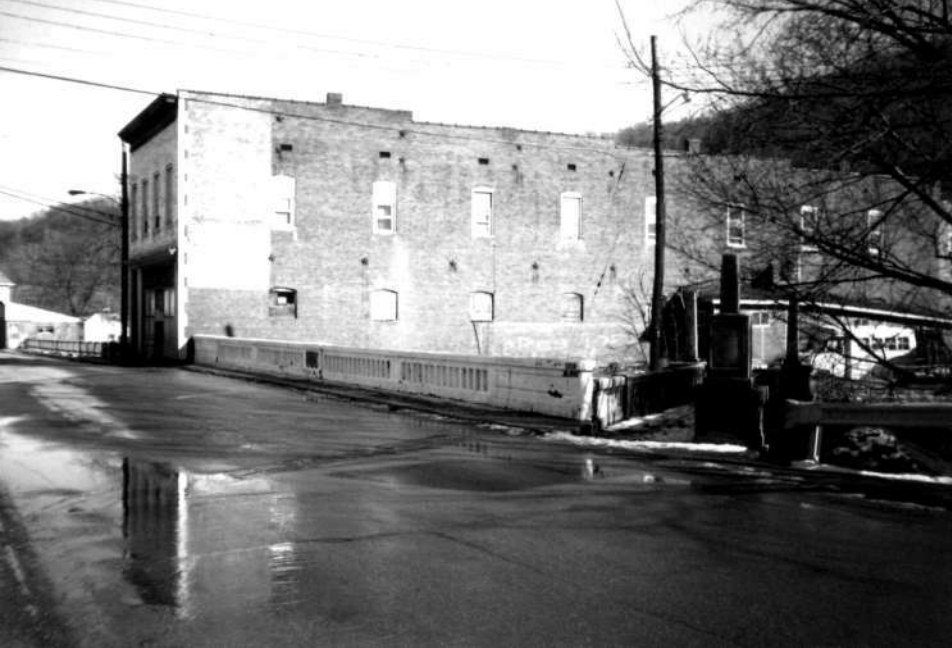
1. AL-V-A-314
2. MD 36 over Jennings Run
3. Allegany Co, MD
4. Ryan McKay
5. 3/97
6. MD SHPO
7. east parapet
8. 5 of 6

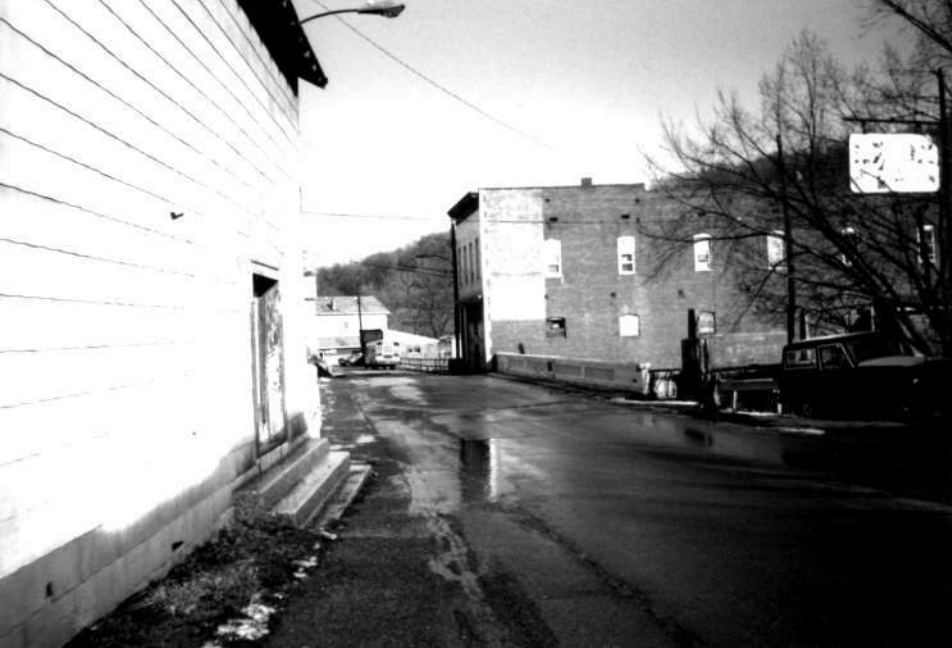
1. AL-V-A-314
2. MD 36 over Jennings Run
3. Allegany Co, MD
4. Ryan McKay
5. 3/97
6. MD STRAD
7. South approach
8. 6 of 6
